Claims Examples – Equipment Breakdown

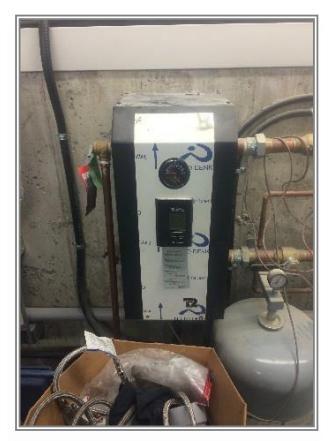
Occupancy: Farm

Cause of loss: equipment failure

Breakdown within a storage tank under pressure. All goods had to be discarded due to rapid change in temperature leading to spoilage. Cost to replace thermostat: \$900 Cost to replace spoiled goods: \$1,800

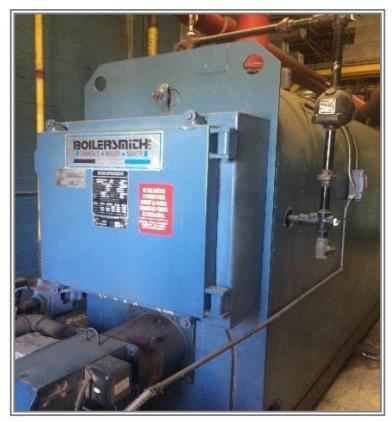
A rupture occurred on a section of a boiler tube connected to the main boiler equipment of the insured. Further investigation as to the cost of breakdown revealed that failure was consistent with excessive oxygen in the boiler feedwater due to insufficient temperature. A temporary boiler unit was rented in order to resume business operations and mitigate loss.

Cost to repair the boiler: \$131,230

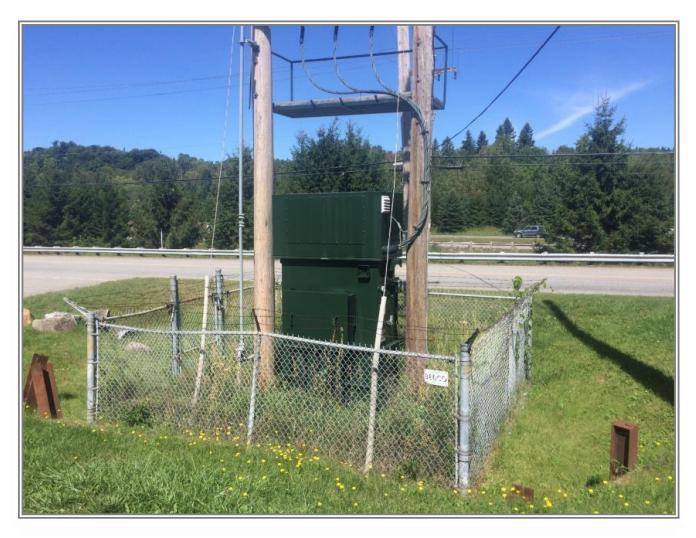
Occupancy: Business owner

A transformer located in a fenced compound exploded shutting down the power to the entire operating section of the insured. In order to maintain operations, the insured rented a large diesel-powered generator to supply power to the plant. This was later replaced with a rental transformer. The rental transformer remained on site until the new transformer was received.

An inspection and testing of the transformer indicated a high level of Ethylene which suggests arcing and the cause of the unit to short-circuit resulting in its failure.

Costs to replace transformer: \$114,787
